## MS1200 OIL IN WATER MONITOR PROTECTS WATER TREATMENT PLANT FROM SPILL

**In November 2018 a Multisensor MS1200 was responsible for saving a water treatment plant in the UK from the disastrous consequences of a Kerosene spill entering the works.**

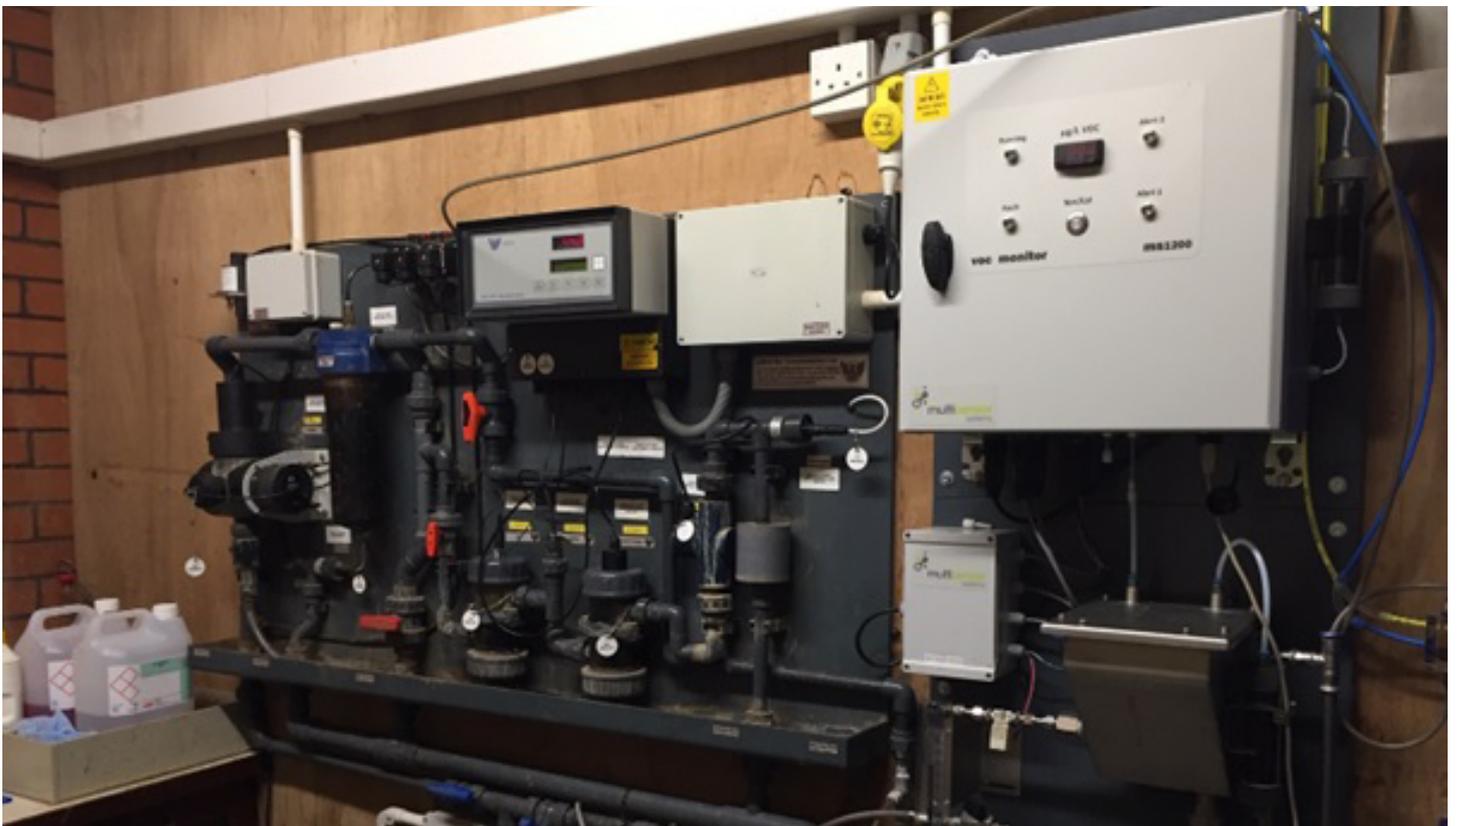
The monitor, installed in October 2014, is located at an intake from a canal which is used to serve a treatment works a few miles away.

The MS1200 is connected directly to a bank of relays which switched off the pumps.

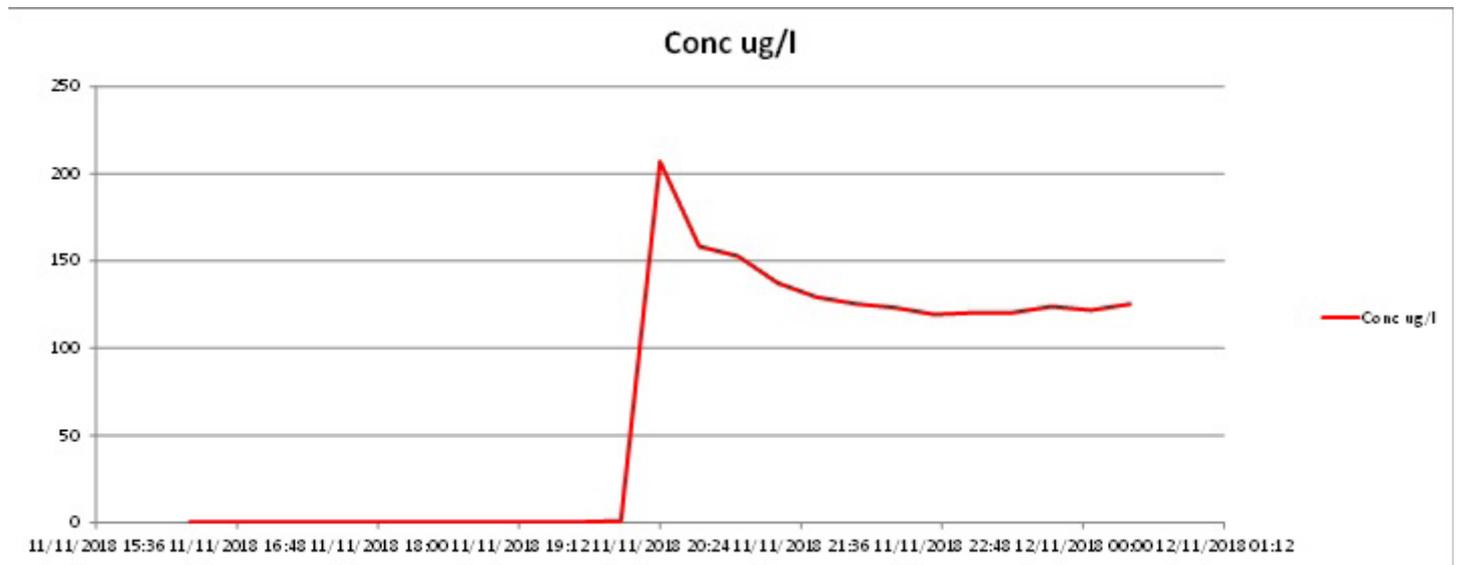
The response of the system is shown below. The level would have continued to rise had the pumps not been turned off quickly.
