Monitoring of Water Intake from Panama Canal

Application Dossier: No. IX

MS1200 Oil in Water Monitor

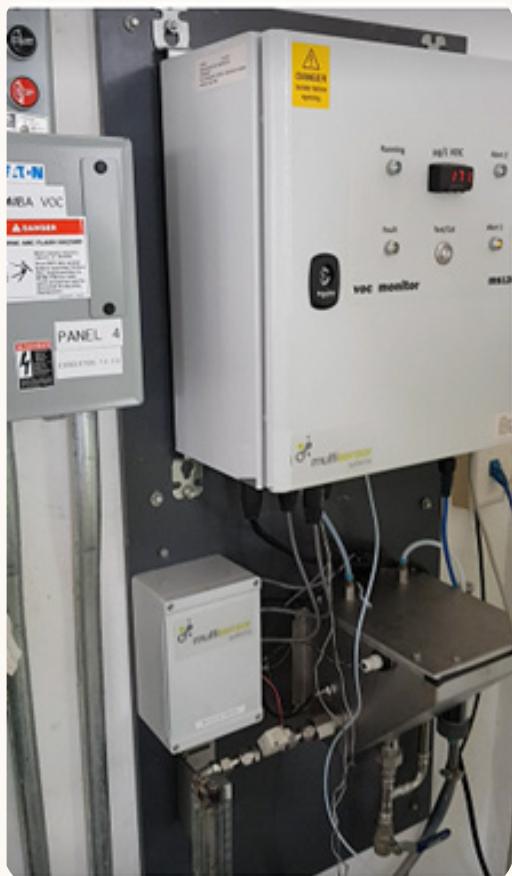
Photo showing the MS1200 installed in the Pump Station. The unit is connected to a SCADA system (Ethernet) using the Profibus Protocol (TCP / IP), which records the data and, in case of an accident, activates the alarms that shut off the suction pumps.

The Canal Authority decided to use the MS1200 system as an early warning system in case of contamination, thus preventing the suspension of the service, high maintenance costs and cleaning tasks that could arise from an oil spill. The instrument is installed in a pumping station about 30 metres from the banks of the Canal from where the water is taken.

The water is analysed for the presence of oil and VOCs every 15 minutes and if there is an increase in the level, an alarm is activated, and an action is taken.
